September 4, 2015

Reference: Response to NCDENR Comments
ERM Report: Environmental Response and Recommendations Report
Sevier Plant/ Coats American WWTP
NPDES Permit No. NC0004243
McDowell County, N.C.

Reference: Site Assessment Plan
Coats American Inc. - Sevier Plant
NPDES Permit No. NC0004243
McDowell County, North Carolina

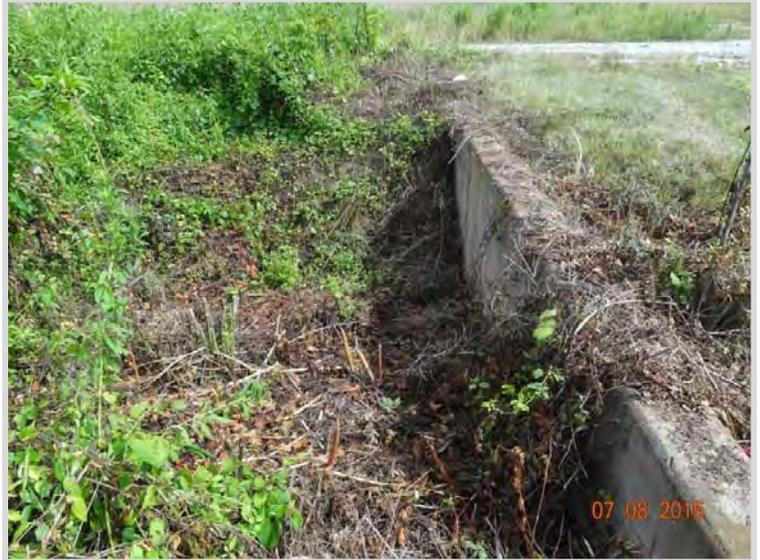
-
- 10) *Page 9, Paragraph 2, Line 1: How was it determined that the grass "burns" were not chemical in nature? Can photos be provided? How will ERM confirm that the area was not impacted by a "spill"?*
-

Response: The brown vegetation was the result of recent “routine cutting and maintenance” activities at the headwall of the Outfall 007 resulting in dead and dying vegetation. Subcontract landscapers are prohibited from using any type of chemical herbicide on the Coats American property. ERM will collect a soil sample from this area to evaluate if a spill has occurred, during the upcoming assessment activities.

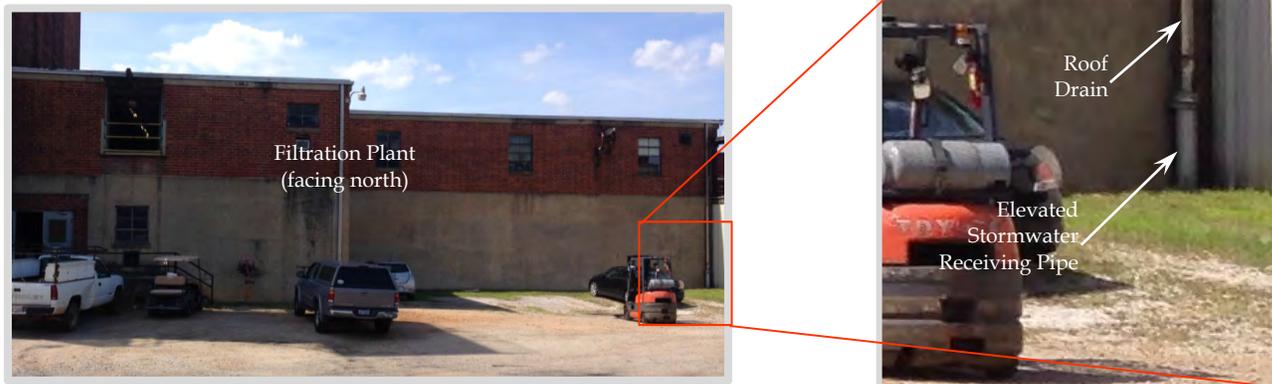
16) Page 10, Paragraph 7, Line 1: Is there potential for an internal plant spill to migrate underneath the external walls and be conveyed through the roof drains (at ground level) to the storm-drainage system?

Response: A chemical spill in the water filtration plant would flow into nearby floor drains due to the slope of the floor. These floor drains will limit accumulation of a potential spill and its potential migration beneath the external walls. The floor drain plumbing was modified in July 2015 to discharge into the process sewer system instead of the storm sewer system. Additionally, the external roof drains typically discharge into the storm drainage system via pipes that are elevated by one to two feet above the surrounding ground surface. This elevated receiving pipe limits intrusion of fluids from any source other than the roof drain. See photos below.

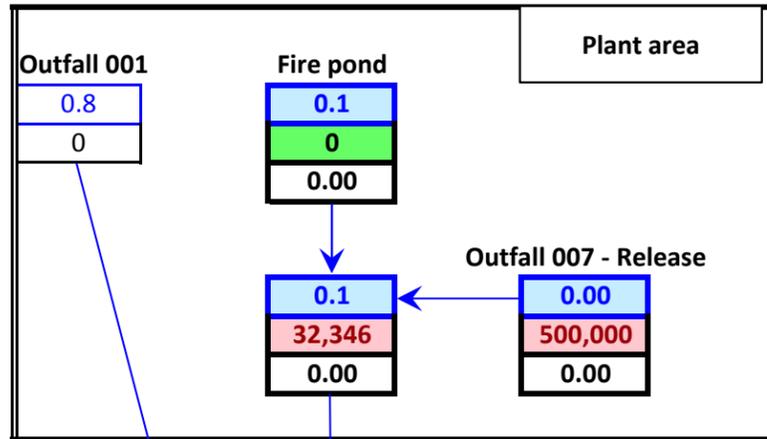
SODIUM HYDROXIDE RELEASE SIMULATION

Response: ERM conducted a dilution analysis to simulate surface water quality and calculate the estimated volume of caustic (sodium hydroxide - 50% solution) required to impact aquatic life within the affected reach the North Fork River. This screening level model indicates that approximately 400 to 500 gallons of caustic would have been necessary to cause the fish kill over the two to three miles of river. The model is attached. Although not a definitive model, we believe it of sufficient quality to establish the amount of caustic that would have been necessary to cause the event in question.
