September 4, 2015

Reference: Response to NCDENR Comments
ERM Report: Environmental Response and Recommendations Report
Sevier Plant/ Coats American WWTP
NPDES Permit No. NC0004243
McDowell County, N.C.

Reference: Site Assessment Plan
Coats American Inc. - Sevier Plant
NPDES Permit No. NC0004243
McDowell County, North Carolina

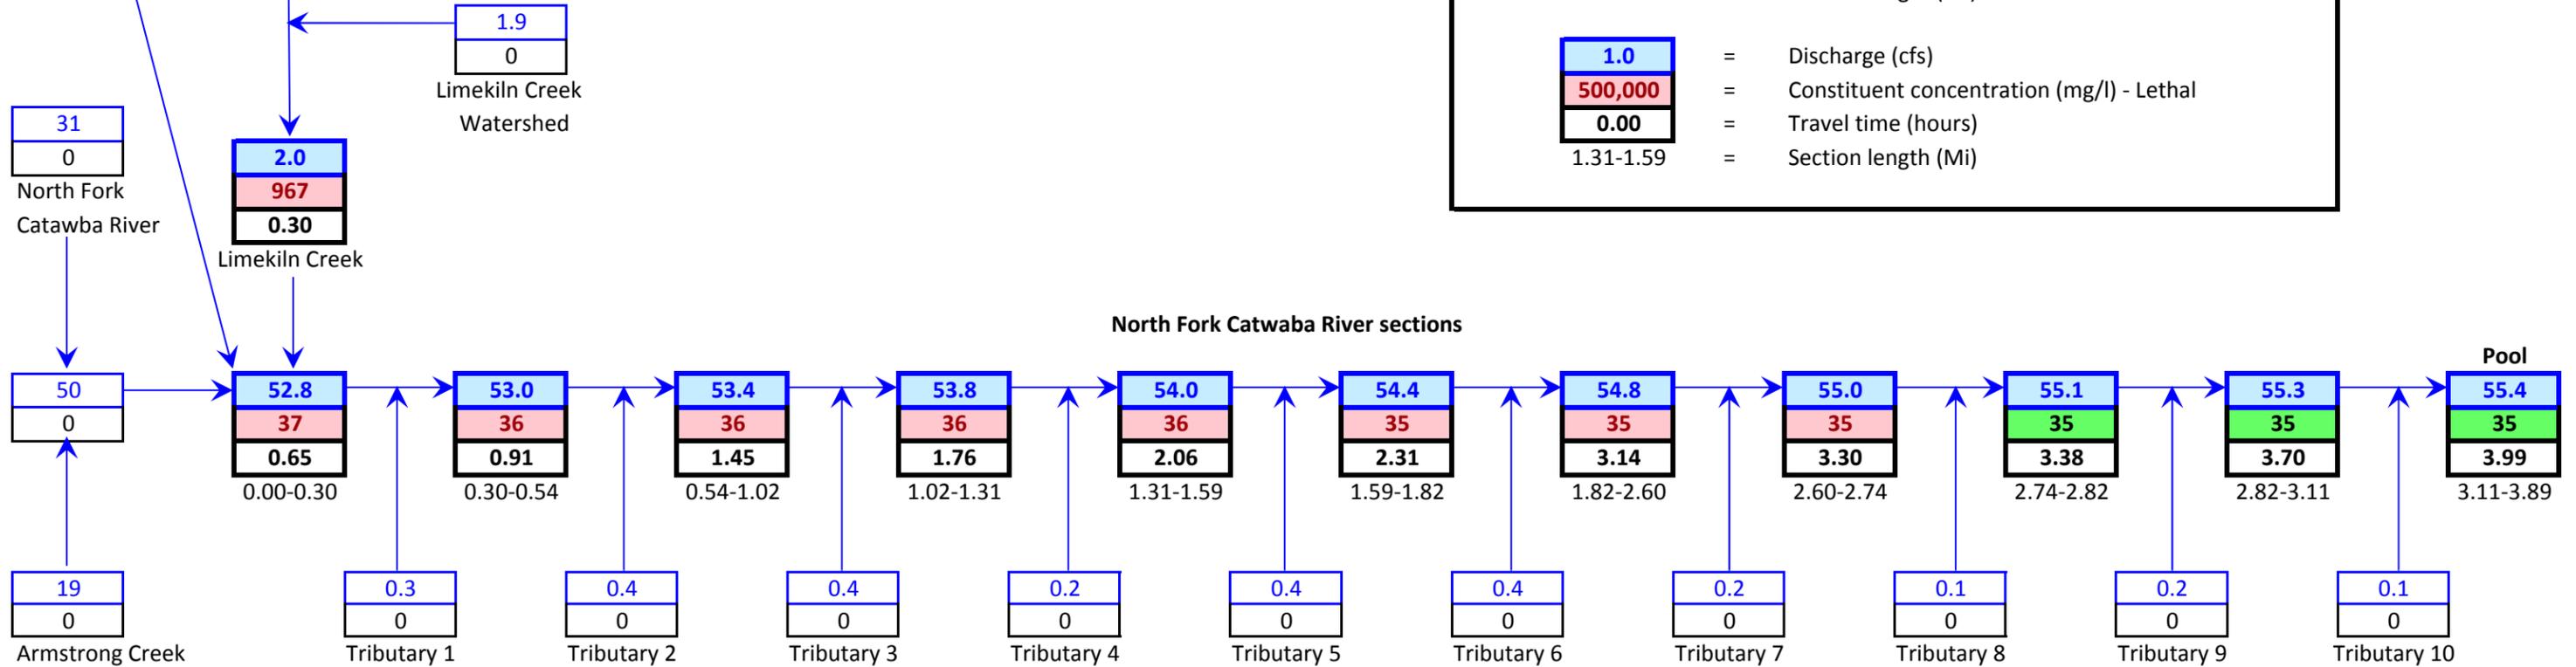
**DILUTION SIMULATION
COATS AMERICAN
NORTH FORK RIVER BASIN
MARION, McDOWELL COUNTY, NORTH CAROLINA**

NaOH - Input data	Dim	Value
Flow upstream of project	cfs	50
Background Caustic	mg/l	0
Fire pond	gpm	25
Outfall 001	mgd	0.5
Volume of release	gal	415
Duration of release	hours	4
Concentration of release	mg/l	500,000
Concentration of fire pond	mg/l	0
Concentration of Outfall 001	mg/l	0
Lethal dose fish LD ₅₀	mg/l	35
